**State of Louisiana  
Department of Natural Resources  
Coastal Engineering Division**

**2006/2007 Annual Inspection  
Report**

**BOSTON CANAL/VERMILION  
BAY SHORE RESTORATION  
PROJECT  
(TV-09)**

May 1, 2007  
Vermilion Parish

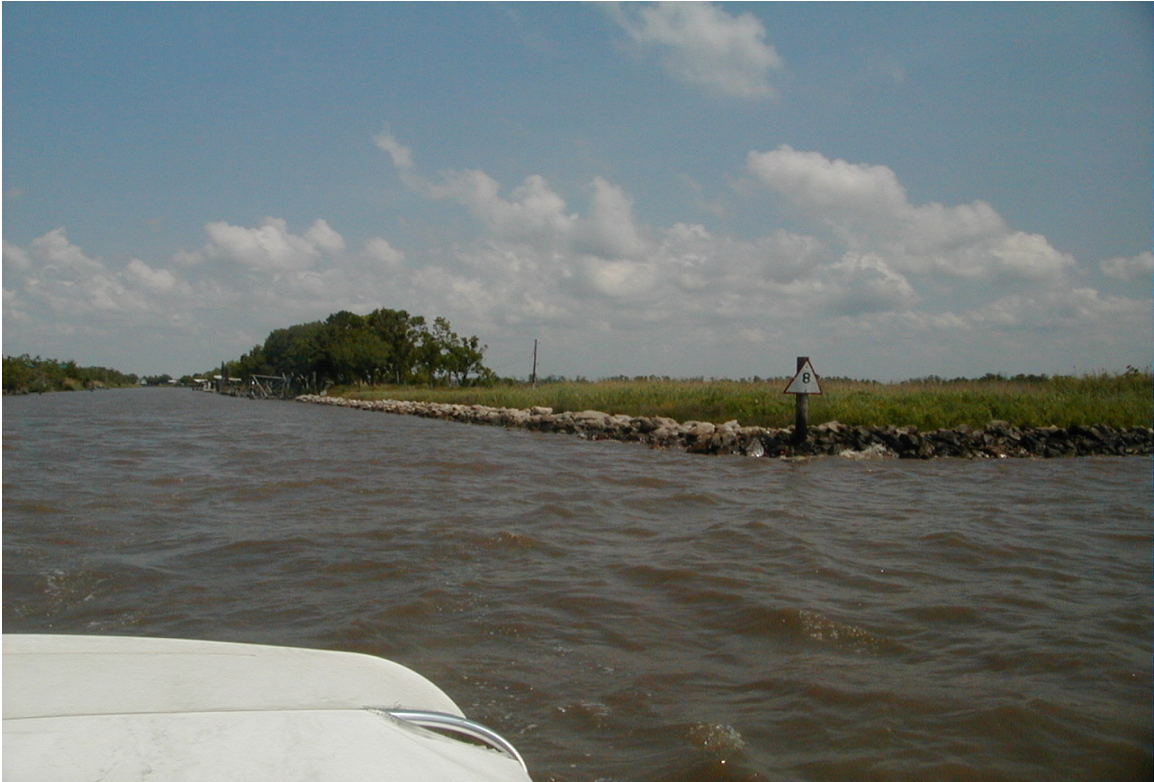
**Photo 1**—east side of Boston Canal
